**RHVP NB to King Street off ramp**

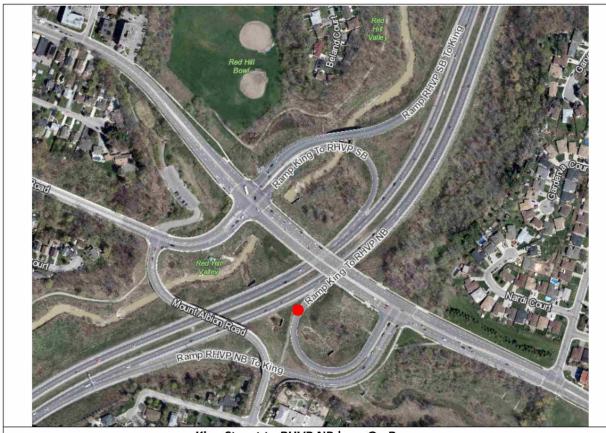
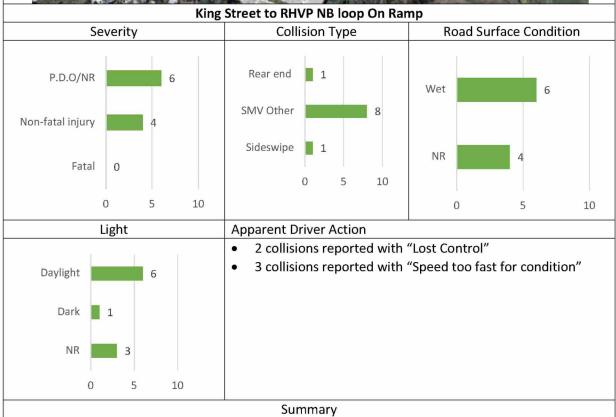
- SMV collisions are the most prevalent collision type
- Majority of the collisions occurred under wet surface conditions

- As an immediate countermeasure, install SLIPPERY WHEN WET sign as a temporary solution
- Resurfacing
- Conduct a ball bank study to identify the advisory speed and install the advisory speed sign if warranted

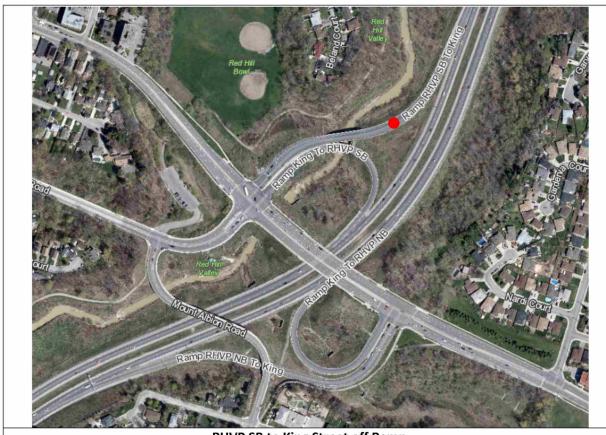
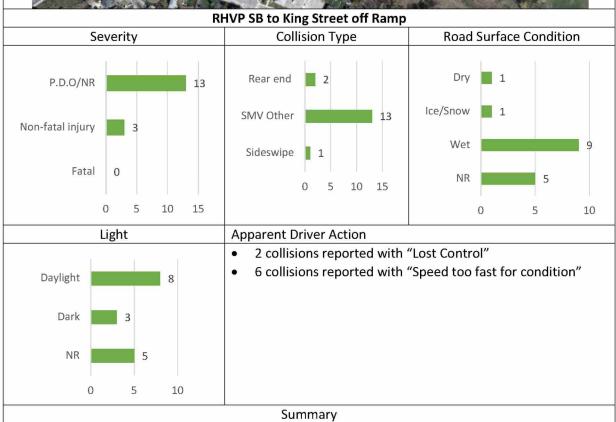
- SMV collisions are the most prevalent collision type
- Majority of the collisions occurred under wet surface conditions
- Most frequent apparent driver action reported was " Speed too fast for condition "

- Resurfacing
- Conduct a ball bank study to identify the advisory speed and install the advisory speed sign if warranted
- Consider the installation of a speed feedback sign

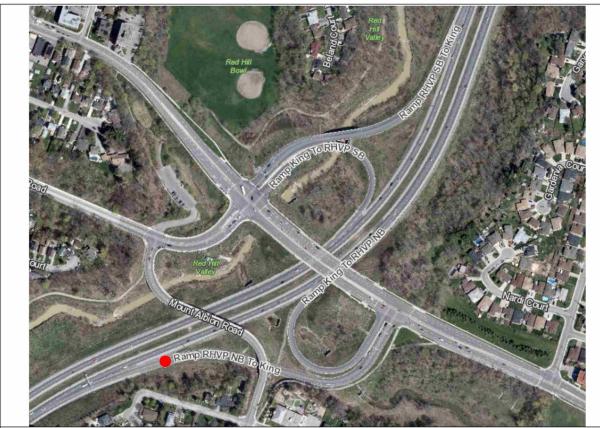
- Only 3 reported collisions within the study period
- 2 occurred under wet surface conditions and apparent driver action reported was "Lost Control"
- No countermeasure is recommended

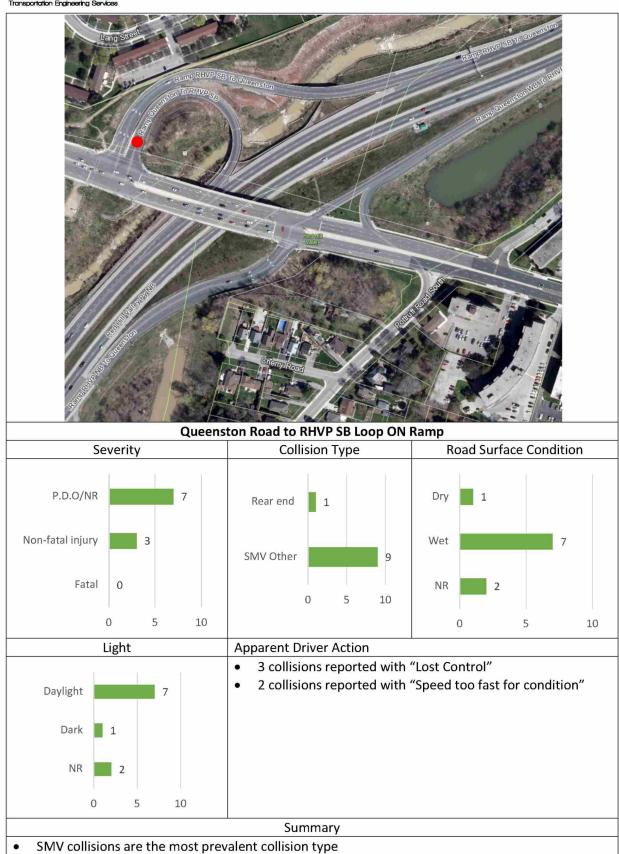
Majority of the collisions occurred under wet surface conditions

- Resurfacing
- Conduct a ball bank study to identify the advisory speed and install the advisory speed sign if warranted
- Consider the installation of a speed feedback sign

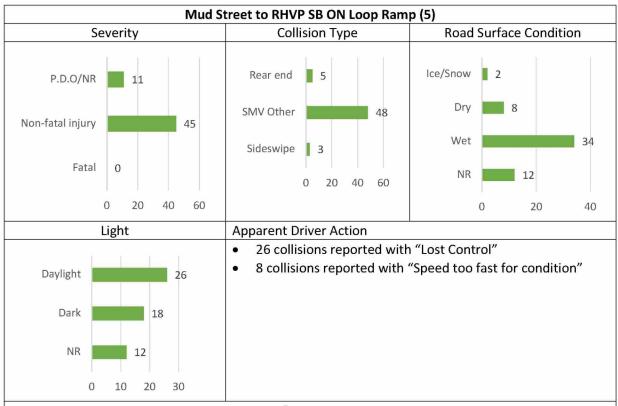
- SMV collisions are the most prevalent collision type
- Majority of the collisions occurred under wet surface conditions
- Most frequent apparent driver action reported was "Lost Control "followed by "Speed too fast for condition"

- Resurfacing
- Conduct a ball bank study to identify the advisory speed and install the advisory speed sign if warranted
- Consider the installation of a speed feedback sign

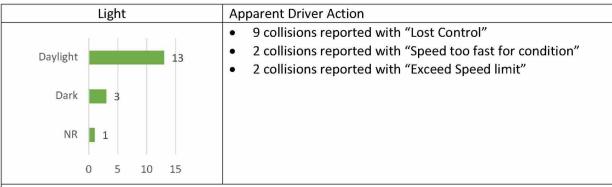
- SMV collisions are the most prevalent collision type
- Majority of the collisions occurred under wet surface conditions
- Most frequent apparent driver action reported was "Lost Control"

- Resurfacing
- Consider the installation of a speed feedback sign

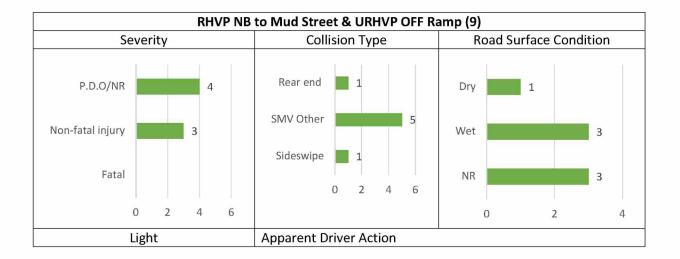
- SMV collisions are the most prevalent collision type
- Most of the collisions occurred under wet surface conditions

Resurfacing

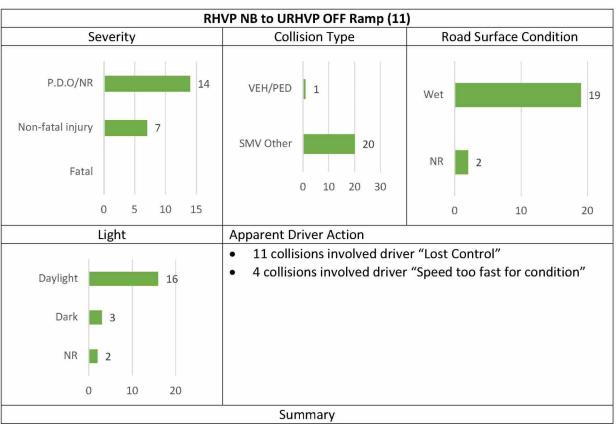
- SMV collisions are the most prevalent collision type
- Majority of the collisions occurred under wet surface conditions

• Most frequent apparent driver action reported was "Lost Control " followed by "Speed too fast for condition"

- Resurfacing
- Conduct a ball bank study to identify the advisory speed and install the advisory speed sign if warranted
- Consider the installation of a speed feedback sign

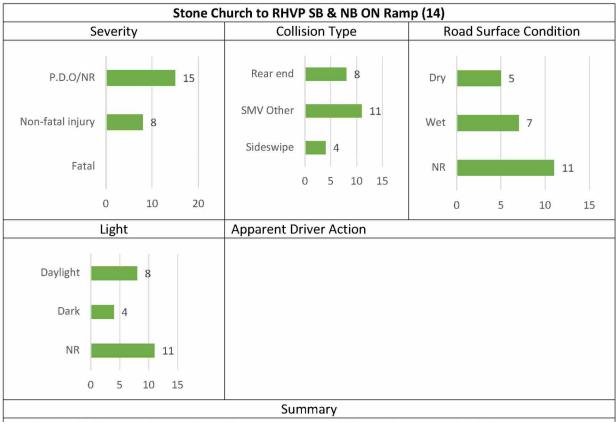
- SMV collisions are the most prevalent collision type followed by rear end collisions
- At least 7 collisions occurred under wet surface conditions

- Resurfacing
- Review the guide signs for the RHVP & LINC

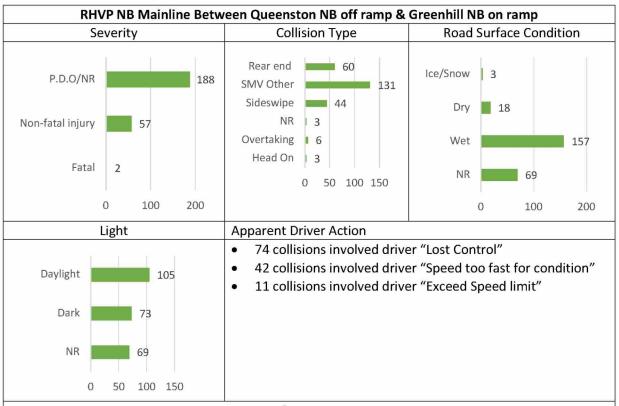
- SMV collisions are the most prevalent collision type followed by rear end and sideswipe collisions
- Wet surface collisions are the most prevalent collision type, which is significantly high compared to typical proportions.
- Majority of SMV, rear end and sideswipe collisions occurred under wet surface conditions.
- The most frequent apparent driver action reported was "lost control", followed by "speed too fast"
- Locations with the highest collision frequencies are located within, on approach to, or leaving horizontal curves

- Provide information sign (or warning sign) where says King Street 500 m saying that right turn exists
- Resurfacing
