City of Hamilton
Red Hill Valley Parkway Safety Review (DRAFT)
B000325 | July 2013
B000325

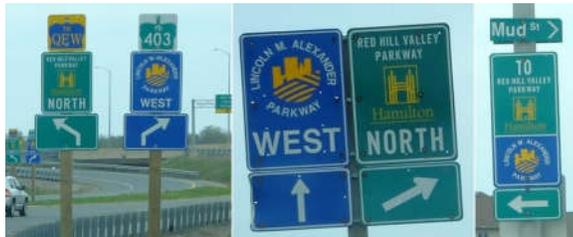
Figure 9 - Trailblazer Information Sign Displays (Various Locations Leading to RHVP/Link On-Ramps)

The trailblazer information sign displays for the RHVP and the Linc contain a lot of information for an approaching road user to read, process, and make an appropriate decision. The displays contain varying colours, shapes, text sizes, and individual signs separated by borders and copy faces. Each display contains a number of individual pieces of information, and in some, a number of different physical signs. The displays are located at decision points where an unfamiliar driver must make a determination in which direction they are intending to travel. Figure 9 illustrates some instances of the identified cases. For example, the sign on the far left includes specific direction to the QEW and 403. For an unfamiliar driver, this information is important and is missing on the sign in the middle. Also note that in the far right photo the largest font for the sign at Mud Street is for the word "TO".

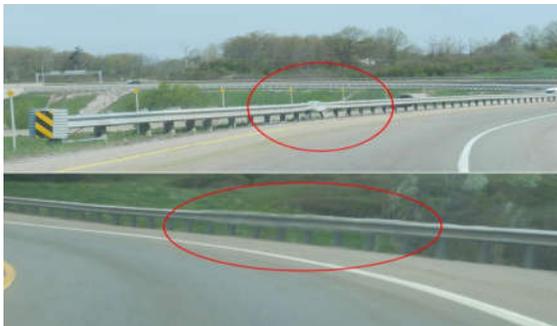
Figure 12 - Dartnall E-S OFF Ramp (View West from the Off-Ramp)

Roadside steel beam guide rail systems and concrete barriers contain evidence of impacting collisions at a number of locations. For the steel beam guide rail systems, depending on the severity, the damage could impede the structural integrity of the system. This could cause the system to function unexpectedly on a subsequent impact. **Figure 12** through **Figure 14** provides illustrative examples of some of the identified cases. Also, a number of plough markers mounted in advance of guide rail system end treatments were damaged and/or not vertically plumb.

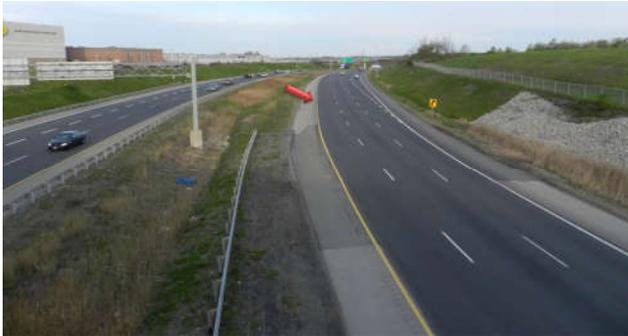
Figure 15 - View of Discontinuity in Horizontal Curve on the Mainline (View West from Pritchard Road Overpass)

discontinuity is very noticeable when viewed from the Pritchard Road overpass. **Figure 15** provides an illustrative example of this issue.

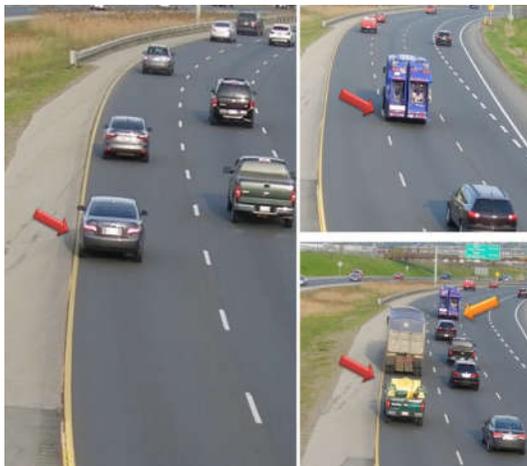
Figure 16 - Observed Cases of Swerve- and Overcorrection-Manoeuvres (View West from Pritchard Road Overpass)

Many drivers were observed traversing or closely approaching the inside (median) edge line of the highway. Some vehicles were observed driving over the rumble strips and then overcorrecting to position themselves back into their travel lane. Overcorrection actions were observed less often during the peak hours, possibly due to lower speeds. **Figure 16** provides illustrative examples of this case.

In the figures, the photos illustrate drivers approaching the edge lines (emphasized with the red-coloured arrow). The picture on the right illustrates the overcorrection manoeuver made by the driver

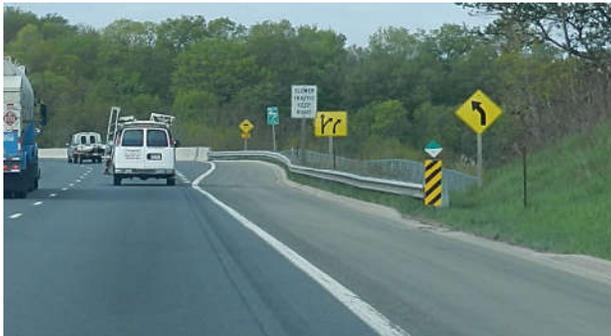
Figure 17 - Closely-Spaced Signage Upstream of the Stone Church Road and Mud Street Off-Ramp (View South from the Mainline)

CLOSELY-SPACED SIGNAGE AND "SLOWER TRAFFIC KEEP RIGHT" SIGN AT DIVERGE POINT (MUD 5)

A group of closely-spaced signs exists between immediately upstream of the Stone Church Road and Mud Street off-ramp. Given the amount of information in a short stretch of road and the fact that this is a critical decision point on the mainline, the message of each sign could be lost and could contribute to driver confusion. **Figure 17** provides an illustrative example. There is also a "SLOWER TRAFFIC KEEP RIGHT" sign installed essentially right at the diverge point for the Stone Church Road / Mud Street diverge point where the right lane becomes a dedicated exit lane. This message may be confusing to road users, and could possibly lead to weaving conflicts. **Figure 18** provides an illustrative example.

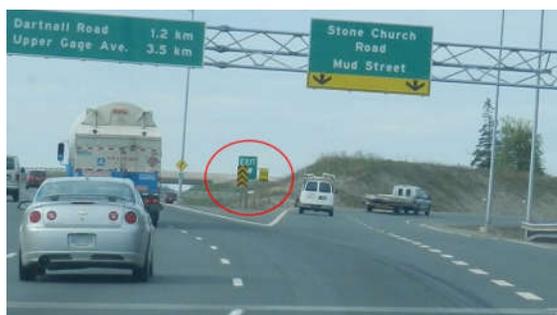
Figure 19 - Freeway Exit sign Partially Eclipsed by the Object Marker Warning Sign (View South from the Mainline)

OBSCURED FREEWAY EXIT SIGN (MUD 5)

The Freeway Exit sign in the gore area of the Stone Church Road / Mud Street off-ramp is partially eclipsed by the Object Marker warning sign on approach. **Figure 19** provides an illustrative example.

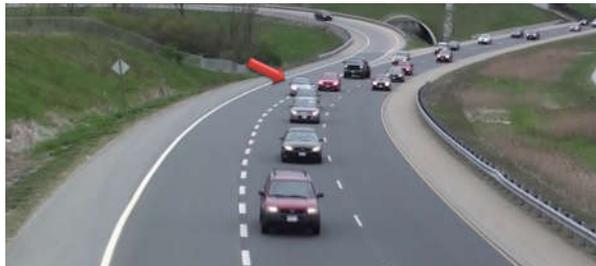
Figure 21 - Potentially Restricted Sightlines for Merging Traffic

POTENTIALLY RESTRICTED SIGHTLINES FOR MERGING TRAFFIC (DARTNALL 4)

The on-ramp merge lane is located within a horizontal curve in the mainline. Vehicles northbound on the mainline and upstream of the ramp may not be easily visible by a merging driver given the curvature of the road and the angle of approach. Many drivers were observed merging onto the mainline immediately downstream of the gore area, even where short gaps were available, which could lead to sideswipe collisions, rear-end collisions or SMV collisions if evasive manoeuvres are undertaken. **Figure 21** provides an illustrative example.

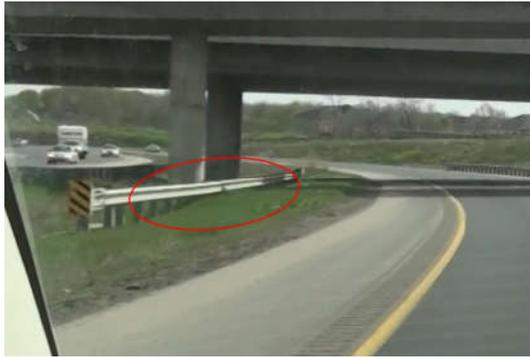
Figure 22 - Uneven Terrain Immediately In Front of the Steel Beam Guide Rail System (View North from the Mainline)

UNEVEN TERRAIN IN FRONT OF GUIDE RAIL (MUD 1)

The terrain is uneven immediately in front of the steel beam guide rail system in the median downstream of the Stone Church Road / Mud Street diverge point. The purpose of the guide rail system is to shield errant vehicles from the columns of the Stone Church Road / Mud Street overpass structure. If an errant vehicle were to run off the road in this location, they would ride up on the uneven grassy terrain in front of the barrier causing the vehicle to strike the system at a higher point than it is designed for. This could lead to the overturning of a vehicle, and possibly continuation into the column being shielded. **Figure 22** provides an illustrative example.

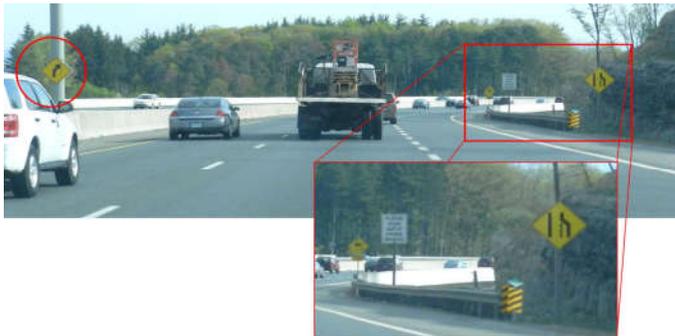
Figure 23 - Closely Spaced Signs within the Vicinity of a Complex Merging Area (View North from the Mainline)

CLOSELY SPACED SIGNAGE (MUD 5)

A “PLEASE AVOID USE OF ENGINE BRAKES” Regulatory sign located downstream of the Mud Street on-ramp between a Lane Drop and Bridge Ices warning sign. These signs are closely spaced and within the vicinity of a complex merging area where drivers from Mud Street are required to perform two consecutive merging maneuvers; one from the Stone Church on-ramp and then another onto the mainline of the RHVP. A curve warning sign also exists on the left side of the road in this area. Given the nature of the location, the warning signs are the highest priority and require the immediate attention of drivers. In its current configuration, the signage in this area could potentially lead to driver-overload and possible conflicts. **Figure 23** provides an illustrative example.

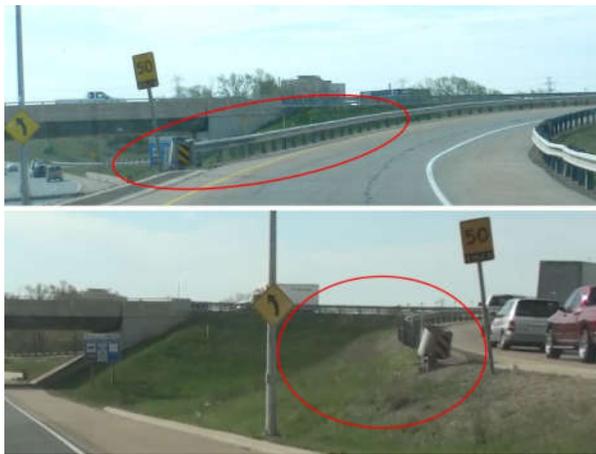
Figure 24 - Damaged and Poorly Designed Guide Rail End Treatment

POORLY DESIGNED AND DAMAGED GUIDE RAIL END TREATMENT

The Eccentric Loader steel beam guide rail end treatment on the outer edge of the Dartnall Road off-ramp is damaged, does not contain a sufficient flat run-out area behind the system, and the system itself on the approach end is leaning out and is not vertically plumb. A vehicle striking this system may not be shielded from the slope as intended. **Figure 24** provides an illustrative example.

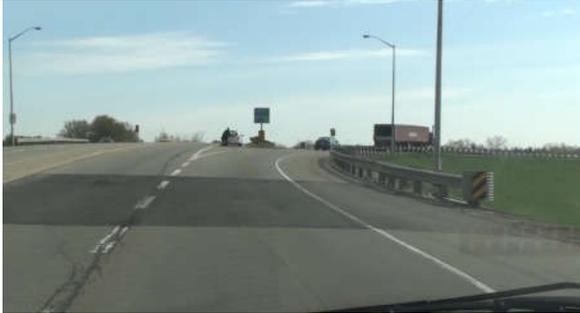
Figure 25 - Pole within Deflection Area of Approach Eccentric Loader End Treatment (View North from Beginning of Off-Ramp)

LUMINAIRE WITHIN DEFLECTION AREA OF APPROACH ECCENTRIC LOADER END TREATMENT

The luminaire pole adjacent to the guide rail system at the beginning of the Dartnall Road on-ramp is within the run-out area of the Eccentric Loader approach end treatment. If the end treatment is stuck, it is possible that the vehicle will also come into contact with the luminaire. **Figure 25** provides an illustrative example.

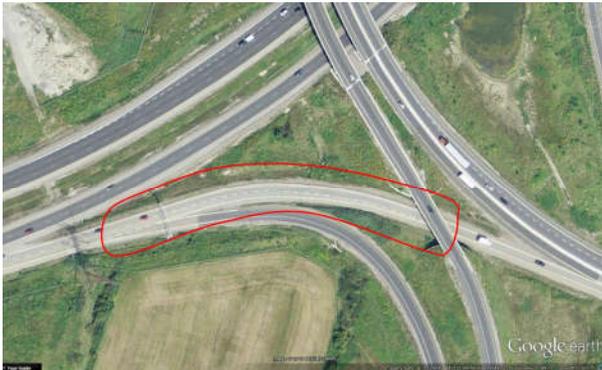
Figure 26 - Outside Lane Ends within Horizontal Curve

The outside (right) lane ends within the horizontal curve downstream of the mainline. The taper ending the lane is fairly short and exists along the length of the curve. This lane essentially ends at the beginning of the curve, forcing traffic to merge within the curve which requires a driver to perform two workload intensive maneuvers at the same time. **Figure 26** provides an illustrative example.

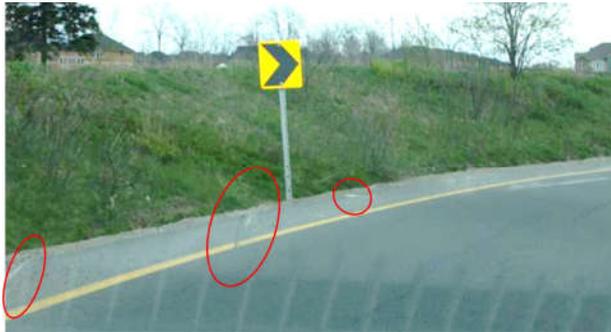
Figure 28 - Evidence of Lane Departures

EVIDENCE OF LANE DEPARTURES

Evidence of vehicles departing the travel lane was identified on the outside of the ramp. In this case, if a vehicle were to leave the traveled portion of the road, it would likely result in damage to a vehicle and possibly injury to its occupants. **Figure 28** provides an illustrative example.

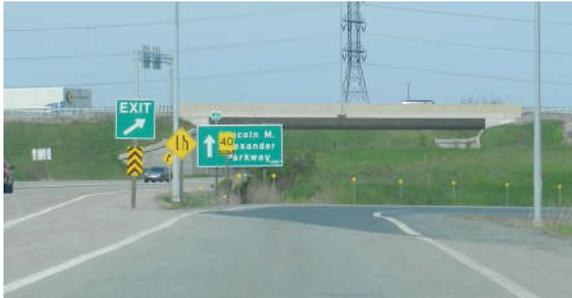
Figure 29 - Closely-Spaced and Eclipsing Signage (View West from Beginning of On-Ramp)

As noted for the Mud Street E-W on-ramp, a group of closely-spaced signage exists in the ramp gore area. The 40 km/h advisory signage for this ramp is placed amongst signage for the Mud Street E-W on-ramp and is easily lost in the jumble. Although sign-eclipsing isn't an issue here, the signs are back-dropped by the information sign for the Linc. Also, the Lane Ends warning sign for the Mud Street E-W on-ramp is located between the Freeway Exit sign and the Mud Street E-W on-ramp information sign, which could cause further confusion. **Figure 29** provides an illustrative example.

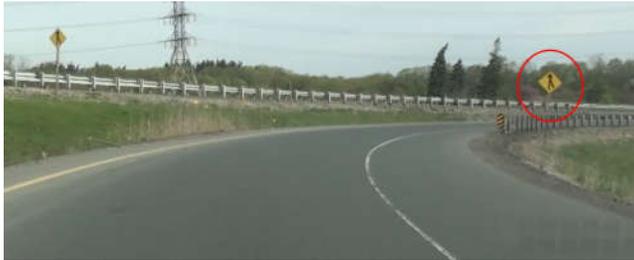
Figure 30 – Inappropriate Merge Warning Sign (View North from On-Ramp)

INAPPROPRIATE WARNING SIGN FOR CONFIGURATION

The Merge warning sign on approach to the Stone Church Road East S-N on-ramp is inappropriate for the configuration. The driver on the E-N ramp is the one who is merging onto the S-N ramp. This sign indicates that another lane is joining from the right and could cause driver confusion. A Lane Ends warning sign is required, as opposed to the Merge warning sign. **Figure 30** provides an illustrative example.

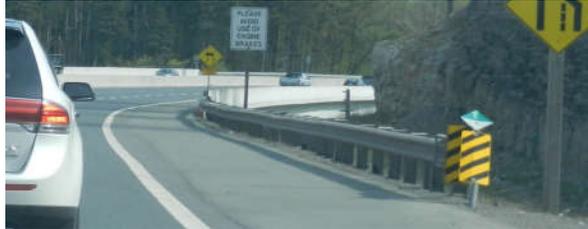
Figure 31 - Object Marker Damaged and Not Vertically Plumb (View North from the Mainline)

OBJECT MARKERS, AND POST-MOUNTED DELINEATORS

The Object Marker warning sign immediately in advance of the Extruder guide rail end treatment downstream of the Stone Church Road / Mud Street merge lane is damaged and not vertically plumb. **Figure 31** provides an illustrative example.

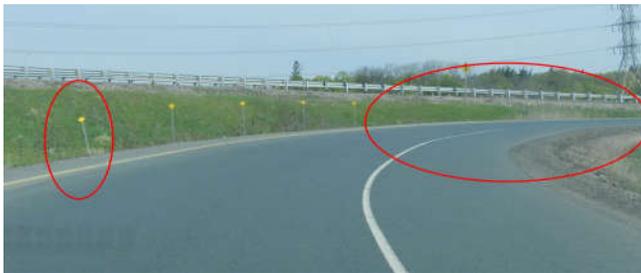
Figure 32 - Damaged Post-Mounted Delineators

DAMAGED POST-MOUNTED DELINEATORS

A number of post-mounted delineators on the outside of the ramp curves appear to have been struck by vehicles and are not vertically plumb. **Figure 32** provides an illustrative example.

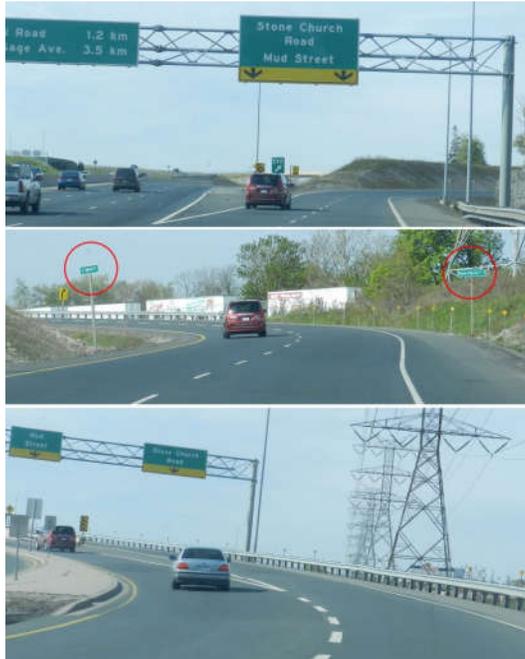
Figure 33 - Information Signs Leading to Mud Street and Stone Church Road (View South Successively Traveling South)

If the small information signs are missed the next available signage to inform road users of the appropriate lane decision are located at the diverge point. However, similar to the previous information signs, given the horizontal curvature of the ramp, the signs are not visible in advance of their placement and sudden lane changes, and potentially related conflicts, may occur in this area. **Figure 33** provides illustrative examples of the drivers' approach to the diverge area.

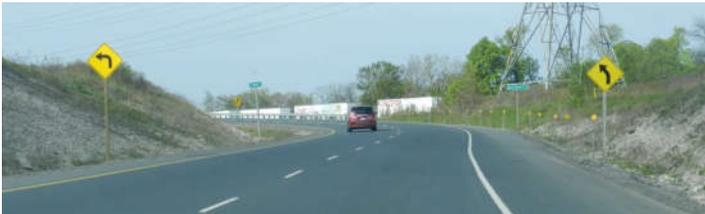
Figure 34 - Conflicting Curve Warning Signs on the Ramp

INCONSISTENT CURVE WARNING SIGNS ON THE RAMP

The curve warning signs on either side of the road on the off-ramp provide inconsistent information regarding the severity of the curve. It is important that consistent and appropriate warning the severity of a curve be provided to a driver in order to assist them in making the appropriate decisions to safely navigate through the curve. **Figure 34** provides an illustrative example of this case.
