City of Hamilton
Red Hill Valley Parkway Safety Review (DRAFT)
B000325 | July 2013
B000325

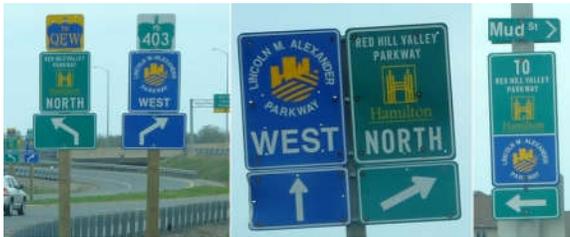
Figure 9 - Trailblazer Information Sign Displays (Various Locations Leading to RHVP/Link On-Ramps)

The trailblazer information sign displays for the RHVP and the Linc contain a lot of information for an approaching road user to read, process, and make an appropriate decision. The displays contain varying colours, shapes, text sizes, and individual signs separated by boarders and copy faces.

Figure 9 illustrates some instances of the identified cases. For example, the sign on the far left includes specific direction to the QEW and 403. For an unfamiliar driver, this information is important and is missing on the sign in the middle.

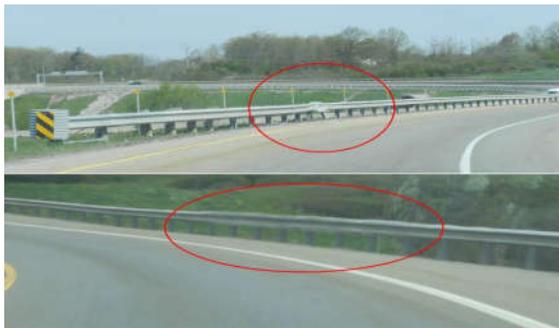
Figure 10.- Dartnall E-S OFF Ramp (View West from the Off-Ramp)

Roadside steel beam guide rail systems and concrete barriers contain evidence of impacting collisions at a number of locations. For the steel beam guide rail systems, depending on the severity, the damage could impede the structural integrity of the system. This could cause the system to function unexpectedly on a subsequent impact. **Figure 12** through **Figure 14** provides illustrative examples of some of the identified cases. Also, a number of plough markers mounted in advance of guide rail system end treatments were damaged and/or not vertically plumb.

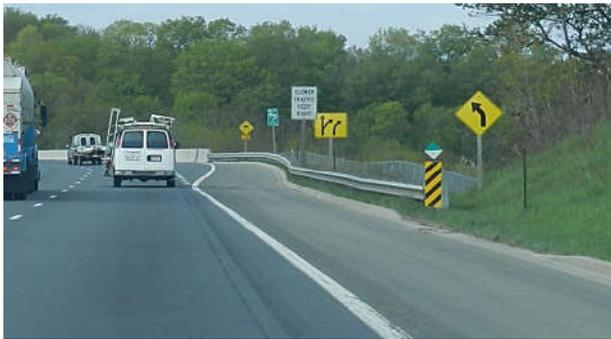
Figure 13 - Closely-Spaced Signage Upstream of the Stone Church Road and Mud Street Off-Ramp |
(View South from the Mainline)

contribute to driver confusion. **Figure 17** provides an illustrative example. There is also a “SLOWER TRAFFIC KEEP RIGHT” sign installed essentially right at the diverge point for the Stone Church Road / Mud Street diverge point where the right lane becomes a dedicated exit lane. This message may be confusing to road users, and could possibly lead to weaving conflicts. **Figure 18** provides an illustrative example.

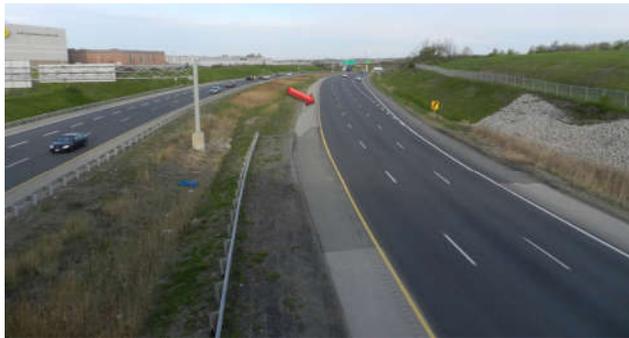
Figure 16 - View of Discontinuity in Horizontal Curve on the Mainline (View West from Pritchard Road Overpass)

The mainline alignment discontinues through the horizontal curve just south of the Pritchard Road overpass. The horizontal curve contains a tangent section part way through the curve. The discontinuity is very noticeable when viewed from the Pritchard Road overpass. Figure 15 provides an illustrative example of this issue.

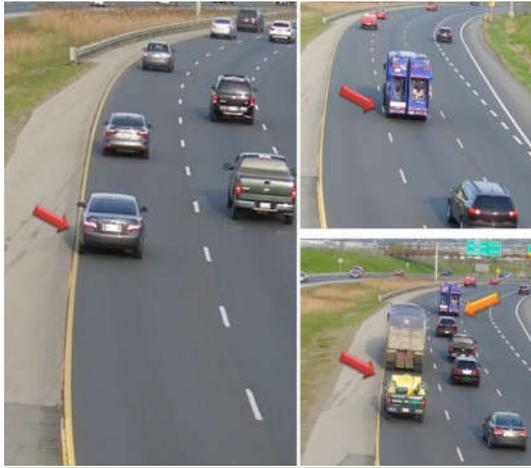
Figure 17.- Observed Cases of Swerve- and Overcorrection-Manoeuvres (View West from Pritchard Road Overpass)

Many drivers were observed traversing or closely approaching the inside (median) edge line of the highway. Some vehicles were observed driving over the rumble strips and then overcorrecting to position themselves back into their travel lane. Overcorrection actions were observed less often during the peak hours, possibly due to lower speeds. Figure 16 provides illustrative examples of this case.

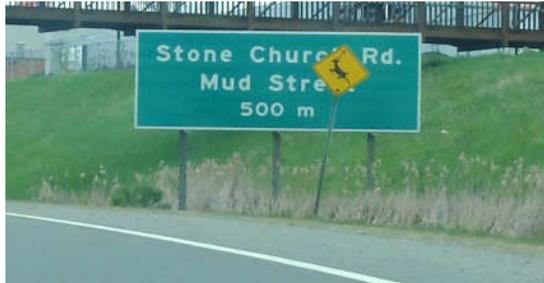
Figure 18.- Deer Crossing Warning Sign Obscuring Information Sign (View North from the Mainline)

The information sign for Stone Church Road / Mud Street located approximately 500 metres upstream of the Stone Church Road / Mud Street off-ramp is marginally eclipsed by the Deer Crossing warning sign immediately in advance. **Figure 20** provides an illustrative example of this case.

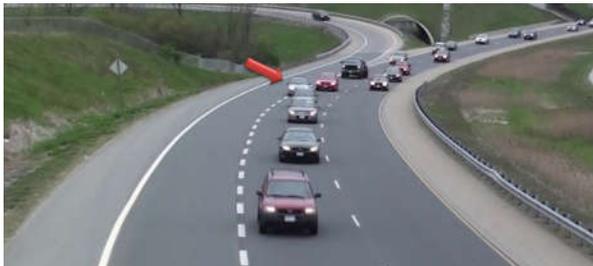
Figure 19.- Potentially Restricted Sightlines for Merging Traffic

The on-ramp merge lane is located within a horizontal curve in the mainline. Vehicles northbound on the mainline and upstream of the ramp may not be easily visible by a merging driver given the curvature of the road and the angle of approach. Many drivers were observed merging onto the mainline immediately downstream of the gore area, even where short gaps were available, which could lead to sideswipe collisions, rear-end collisions or SMV collisions if evasive manoeuvres are undertaken. **Figure 21** provides an illustrative example.

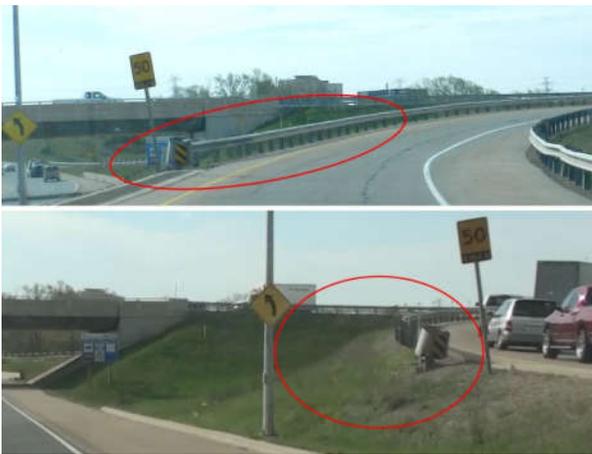
Figure 22 - Damaged and Poorly Designed Guide Rail End Treatment

The Eccentric Loader steel beam guide rail end treatment on the outer edge of the Dartnall Road off-ramp is damaged, does not contain a sufficient flat run-out area behind the system, and the system itself on the approach end is leaning out and is not vertically plumb. A vehicle striking this system may not be shielded from the slope as intended. **Figure 24** provides an illustrative example.

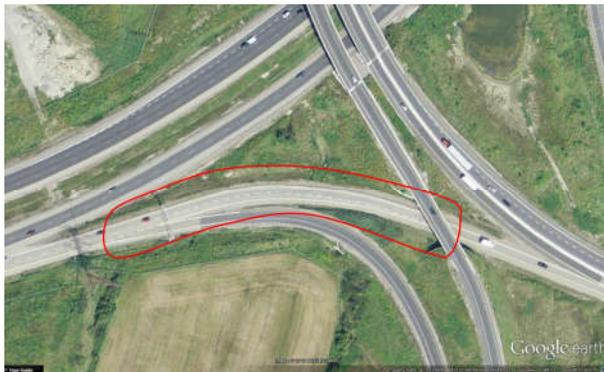
Figure 24 - Outside Lane Ends within Horizontal Curve

The outside (right) lane ends within the horizontal curve downstream of the mainline. The taper ending the lane is fairly short and exists along the length of the curve. This lane essentially ends at the beginning of the curve, forcing traffic to merge within the curve which requires a driver to perform two workload intensive maneuvers at the same time. Figure 26 provides an illustrative example.

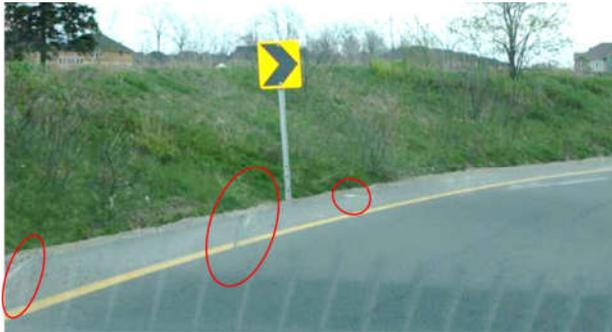
Figure 26 - Evidence of Lane Departures

Evidence of vehicles departing the travel lane was identified on the outside of the ramp. In this case, if a vehicle were to leave the traveled portion of the road, it would likely result in damage to a vehicle and possibly injury to its occupants. Figure 28 provides an illustrative example.

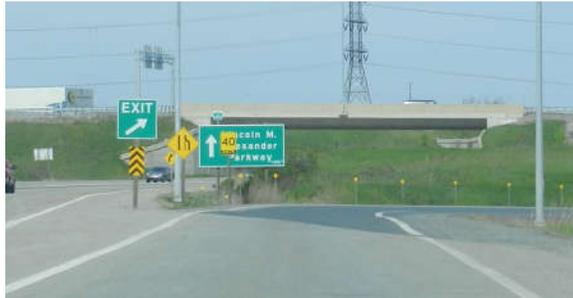
Figure 27.- Closely-Spaced and Eclipsing Signage (View West from Beginning of On-Ramp)

As noted for the Mud Street E-W on-ramp, a group of closely-spaced signage exists in the ramp gore area. The 40 km/h advisory signage for this ramp is placed amongst signage for the Mud Street E-W on-ramp and is easily lost in the jumble. Although sign-eclipsing isn't an issue here, the signs are back-dropped by the information sign for the Linc. Also, the Lane Ends warning sign for the Mud Street E-W on-ramp is located between the Freeway Exit sign and the Mud Street E-W on-ramp information sign, which could cause further confusion. Figure 29 provides an illustrative example.

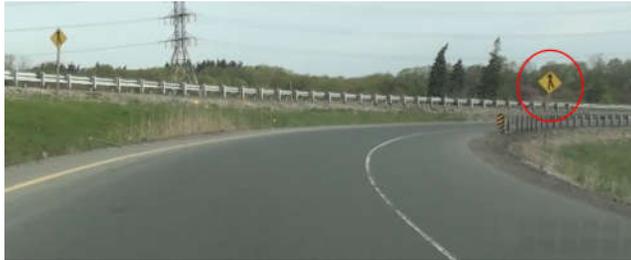
Figure 28.- Inappropriate Merge Warning Sign (View North from On-Ramp)

The Merge warning sign on approach to the Stone Church Road East S-N on-ramp is inappropriate for the configuration. The driver on the E-N ramp is the one who is merging onto the S-N ramp. This sign indicates that another lane is joining from the right and could cause driver confusion. A Lane Ends warning sign is required, as opposed to the Merge warning sign. Figure 30 provides an illustrative example.

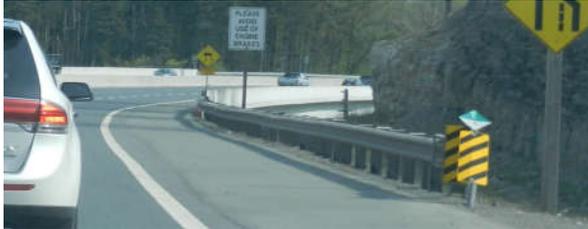
Figure 29 - Object Marker Damaged and Not Vertically Plumb (View North from the Mainline)

The Object Marker warning sign immediately in advance of the Extruder guide rail end treatment downstream of the Stone Church Road / Mud Street merge lane is damaged and not vertically plumb. Figure 31 provides an illustrative example.

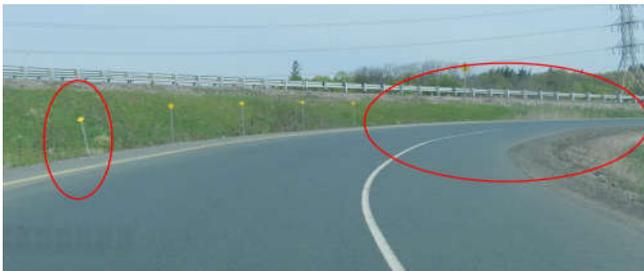
Figure 30 - Damaged Post-Mounted Delineators

A number of post-mounted delineators on the outside of the ramp curves appear to have been struck by vehicles and are not vertically plumb. **Figure 32** provides an illustrative example.

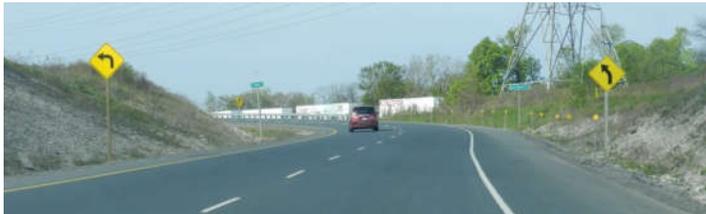
Figure 32 - Conflicting Curve Warning Signs on the Ramp

The curve warning signs on either side of the road on the off-ramp provide inconsistent information regarding the severity of the curve. It is important that consistent and appropriate warning the severity of a curve be provided to a driver in order to assist them in making the appropriate decisions to safety navigate through the curve. Figure 34 provides an illustrative example of this case.
