Report of the Red Hill Valley Parkway Inquiry

Volume 1

The Honourable Mr. Justice
Herman J. Wilton-Siegel
Commissioner

Executive Summary

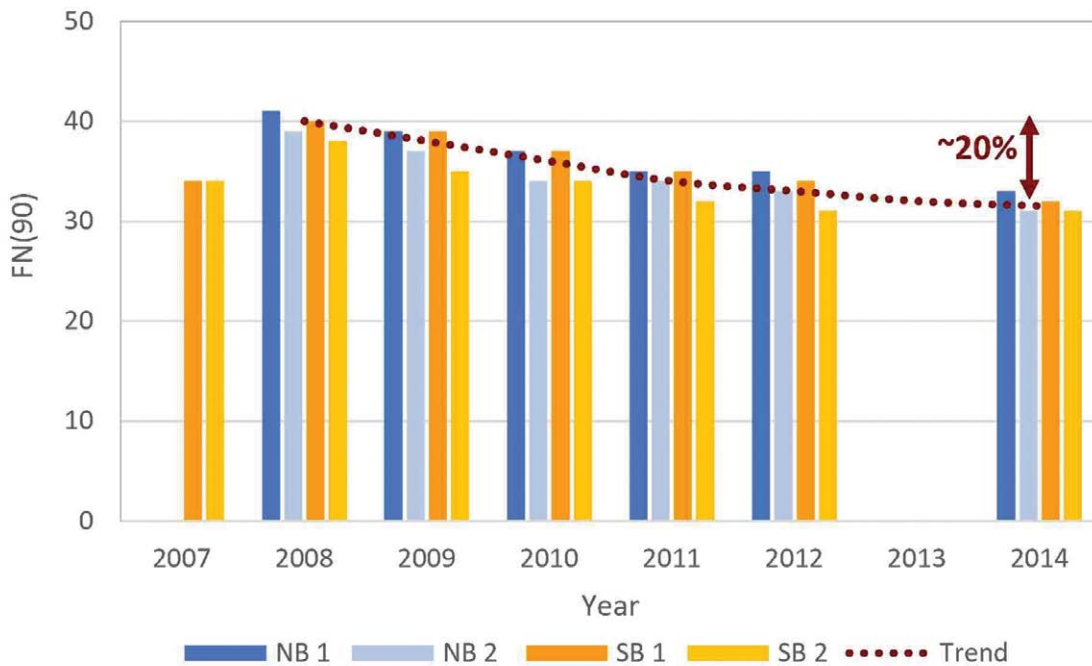
Figure 3p: Trajectory of RHVP Friction Results

As set out in **Figure 3o**, the 2014 RHVP results reflect a decline in average friction values in all four lanes over the course of the testing period.⁵

⁵ For comparison purposes, this chart reflects the decline between 2008 to 2014, since the 2007 testing reflects the early age SMA testing and only includes testing data for the two southbound lanes.

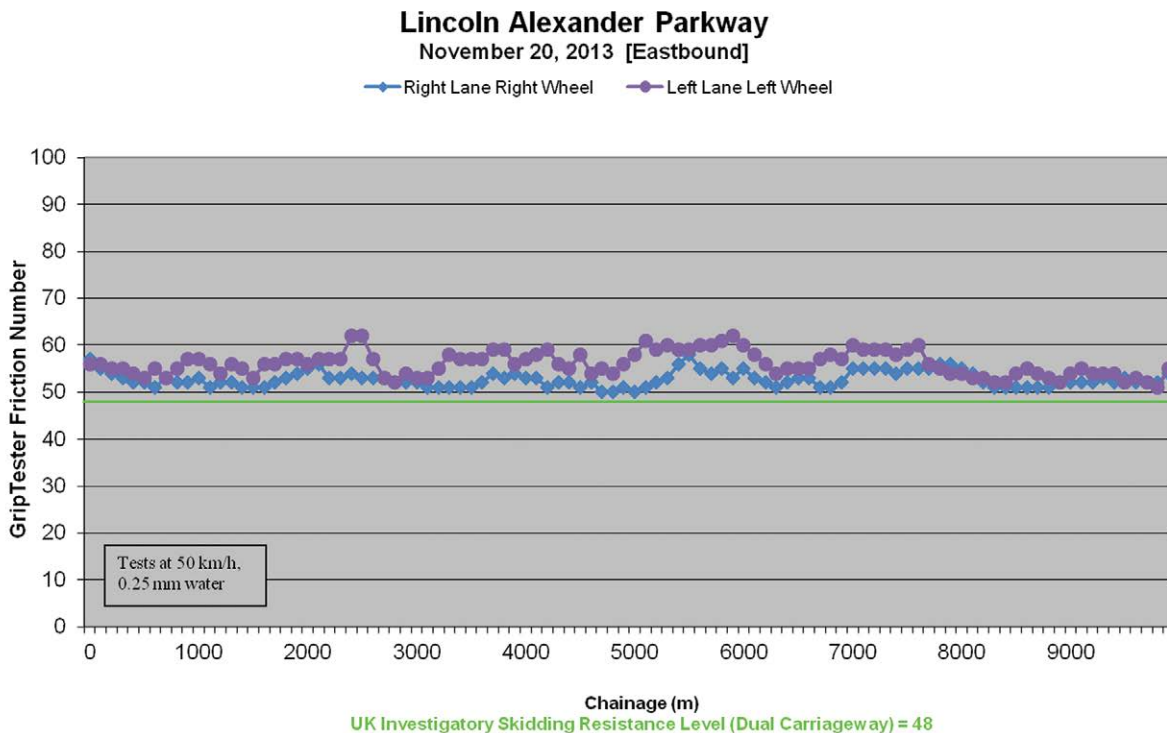
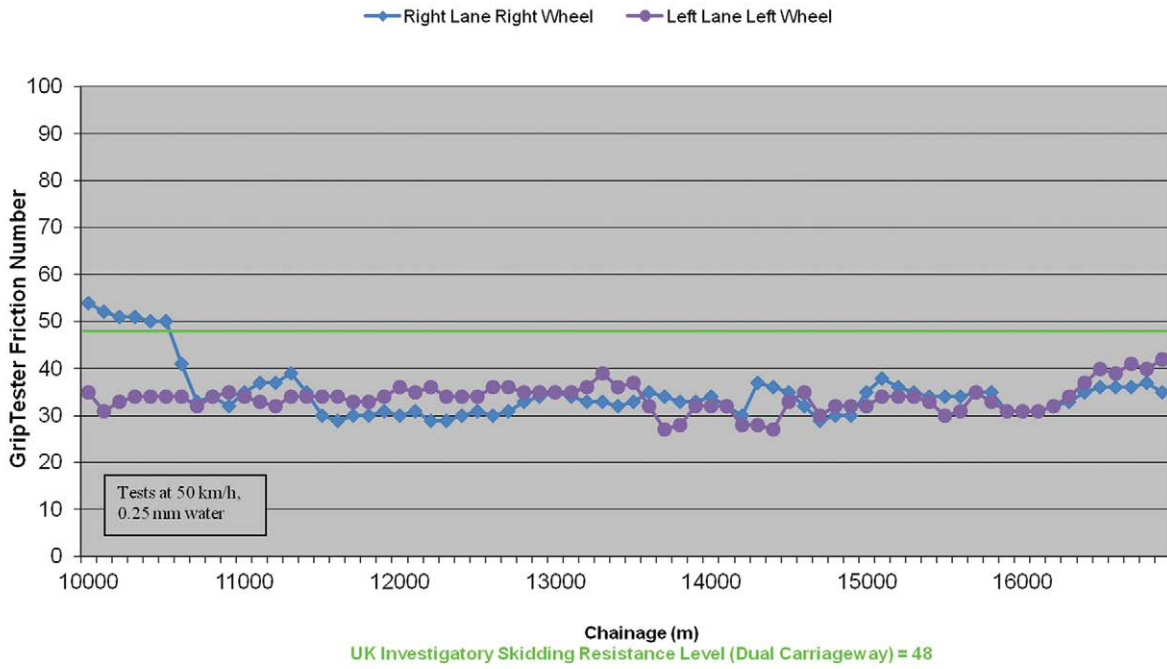
Figure 6g: Friction Values from Tradewind’s Eastbound LINC and Northbound RHVP Test Runs

Tradewind found that the average results from the LINC were “generally *comparable to or above* the reference Investigatory Level 2 (Grip Number = 48).” It also found the LINC results from the four test runs to have “displayed remarkable consistency when subdivided into 100m section values.” Tradewind explained that this “indicates a high level of uniformity in the surface texture and pavement composition along the full extent of the road”.

In contrast, Tradewind found the average results from the RHVP to be “generally *well below* the reference Investigatory Level 2. Most of the length of the RHVP had Grip Numbers in the range of 30-40. Only a short section, approximately 600m in length, of the right hand wheel track of the right hand (outside) lanes near the southwest end of the Parkway had friction values above the UK Investigatory Level 2.”
