Friction Testing Survey Summary Report

Lincoln Alexander & Red Hill Valley Parkways (Hamilton)

November 20th, 2013

Tradewind Scientific Ltd. Ottawa, Ontario, Canada January 2014

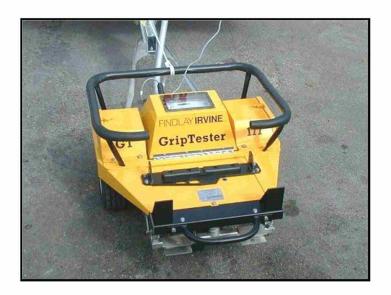
Figure 1: Findlay Irvine Mk 3 GripTester

Friction measurements for the present survey were made using a GripTester instrument (manufactured by Findlay Irvine Ltd. of Scotland) which is an ICAO listed and FAA approved runway friction measurement device and one that is used extensively by road authorities in the U.K., Australia and New Zealand. For the current survey, a tow vehicle owned and operated by Tradewind Scientific Ltd. was configured with a 500 litre flexible water tank and an electric pump and ball-valve flow regulation system in order to undertake the friction test runs under controlled self-watering conditions. Project coordination and on-site assistance was provided by Vimy Henderson, Pavement and Materials Engineer, Golder & Associates Ltd.

GripTester Friction measurements were undertaken on the Lincoln Alexander and Red Hill Valley Parkways under standard test conditions of 50 km/hr and 0.25mm applied water film depth, using an ASTM 1844 Test Tire inflated to 140 KPa (20 psi).

In order to ensure that the friction measurements met high standards of accuracy and repeatability, the GripTester was subjected to full primary load/drag calibration procedures prior to the test survey and both the load zero and drag zero offsets were verified following the work.

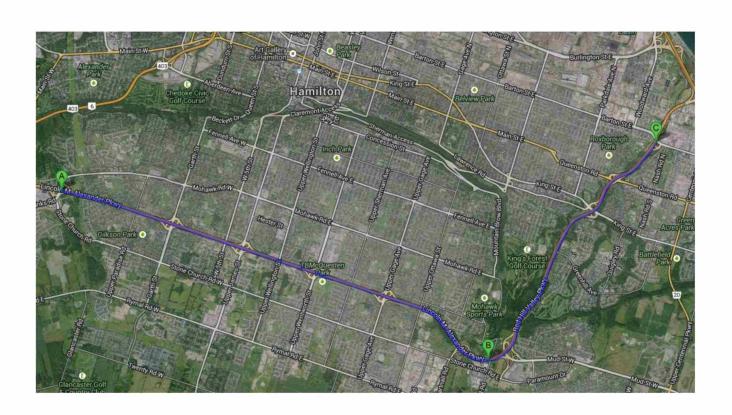
Figure 2 Approximate map of the tested portion of Lincoln Alexander (A \rightarrow B) and Red Hill Valley (B \rightarrow C) Parkways.. Courtesv of Google/DigitalGlobe.

Figure 2 shows the approximate locations of the surveyed road sections, both of which are near the periphery of the city of Hamilton, Ontario, adjacent to the western end of Lake Ontario.

Five full length test runs were completed on both the Lincoln Alexander and Red Hill Valley Parkways. One test run was conducted in the right hand wheel path of each lane of each road in both directions (Eastbound and Westbound) as well as a single reference centreline run in the right hand lane on both roads (Eastbound).
