**RHVP NB to King Street off ramp**

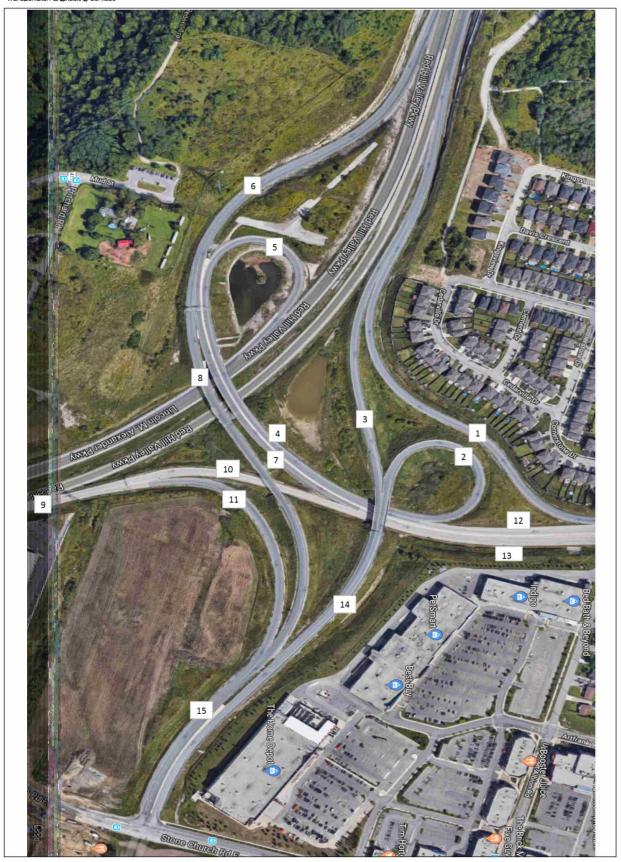
Majority of the collisions occurred under wet surface conditions

- Resurfacing
- Conduct a ball bank study to identify the advisory speed and install the advisory speed sign if warranted
- Consider the installation of a speed feedback sign

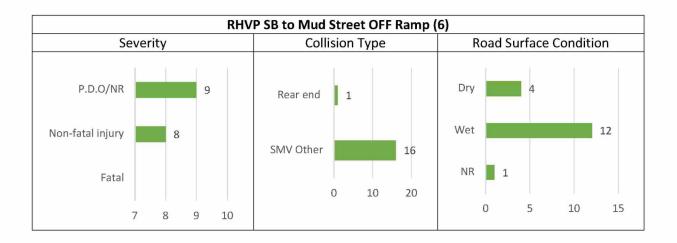
- SMV collisions are the most prevalent collision type
- Majority of the collisions occurred under wet surface conditions
- Most frequent apparent driver action reported was "Lost Control "followed by "Speed too fast for condition"

- Resurfacing
- Conduct a ball bank study to identify the advisory speed and install the advisory speed sign if warranted
- Consider the installation of a speed feedback sign
