City of Hamilton
Red Hill Valley Parkway Safety Review (DRAFT)
B000325 | July 2013
B000325

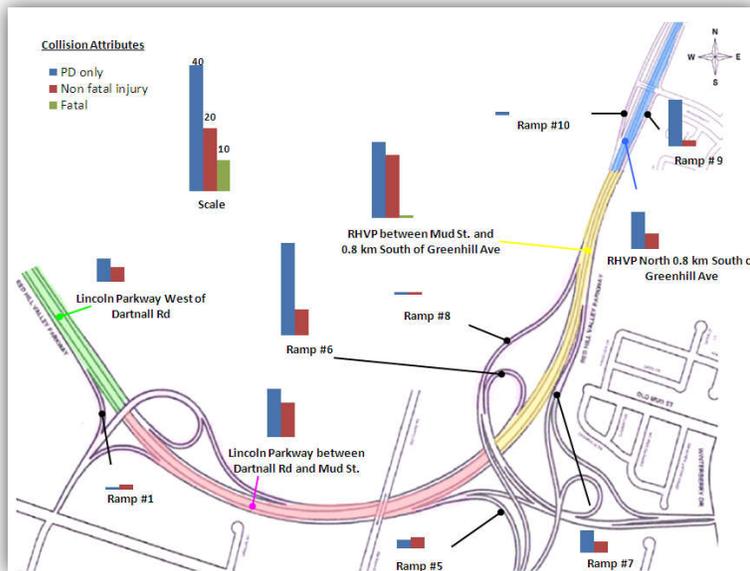
Figure 3 - Collision Bar Diagrams – Severity

Only one fatal collision occurred during the study period. The fatal collision was observed on the mainline segment of the RHVP between Mud Street and 0.8 km South of Greenhill Avenue.

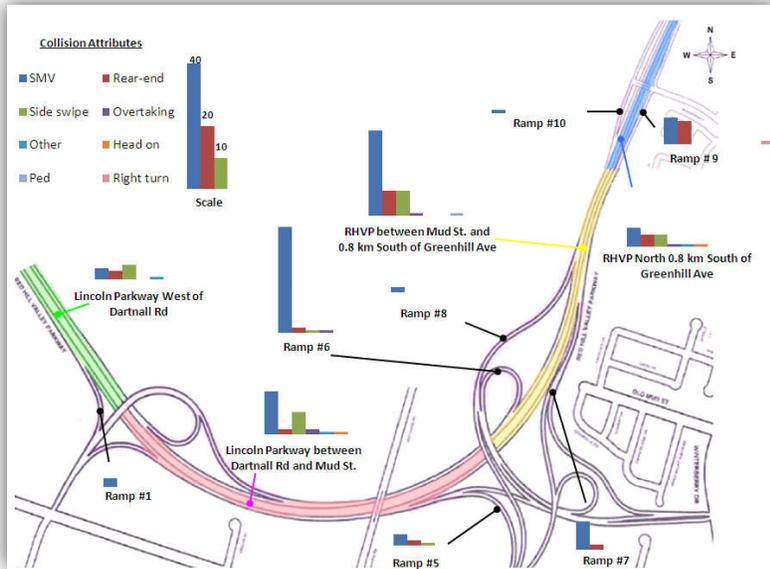
Figure 4 - Collision Bar Diagram - Impact Type

The most common impact type observed within the study area is SMV, with an overall proportion of 63%. This proportion of SMV collisions is significantly higher on Ramp 6, where more than 90% of collisions are SMVs. These findings are is is finding is notable, especially when compared to the 2010 Provincial average⁵, which is 24%.

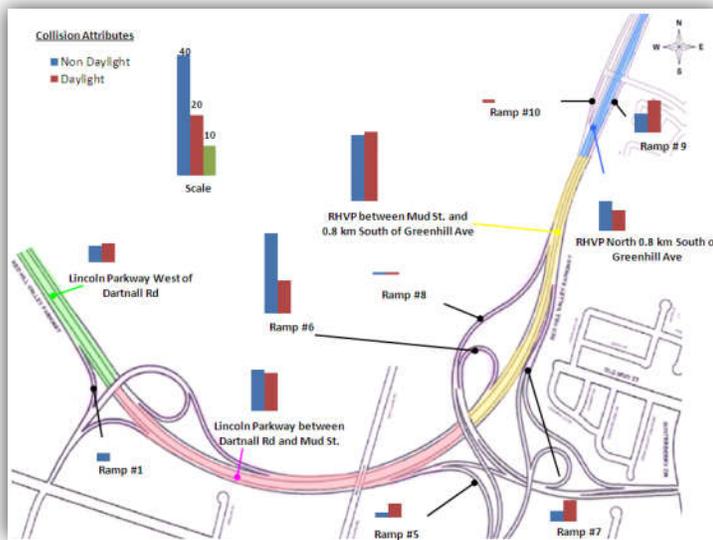
Figure 5 - Collision Bar Diagram – Lighting

The study area experienced an atypically high proportion of non-daylight collisions. In fact, according to the 2010 Ontario Road Safety Annual Report (ORSAR)⁶, less than 30% of all collisions in Ontario occurred during non-daylight conditions. However, in comparison with the proportion of non-daylight collisions observed within the study area (53%), there is a difference of more than 23% with the Provincial average. The road element that experienced the greatest proportion of non-daylight collisions is Ramp 6, with a proportion of 71%.

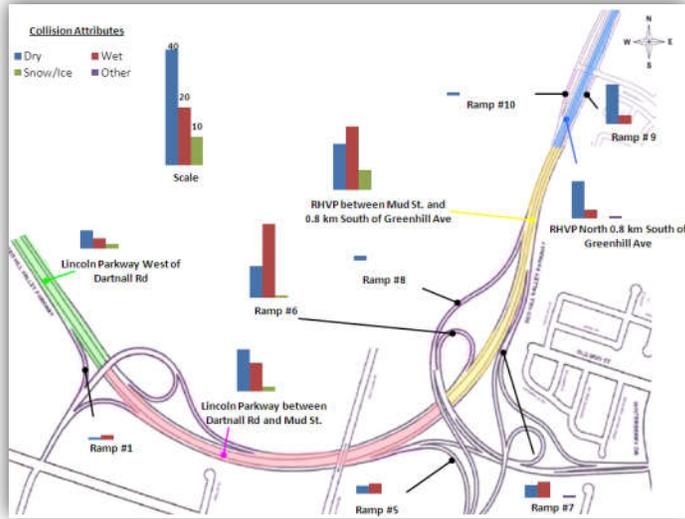
Figure 6 - Collision Bar Diagram – Road Surface

The study area overall average of collisions that occurred under wet road surface condition is 45%. When compared to the Provincial average of 17.4%⁷, the proportion of collisions under wet road surface is significantly higher. This difference is mainly attributable to Ramp 6 and the mainline segment of RHVP between Mud Street and 0.8 km South of Greenhill Avenue, where the proportions of collisions that occurred under wet road surface conditions are 68% and 49%, respectively.

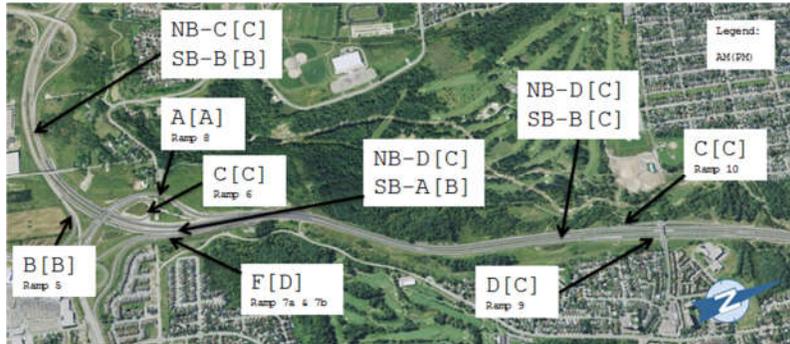
Figure 8 - Results of Operational Analysis for AM and PM Peak Periods

A high level review of traffic operations was undertaken for the study area. Highway Capacity Software (HCS) 2010 was utilized to examine the mainline and the ramps during the AM and PM peak periods. It was found that, generally, the study area operates well with most segments and ramps experiencing LOS "C" or better, although there are some exceptions. Figure 8 summarizes the LOS for the various elements for the AM and PM peak periods.

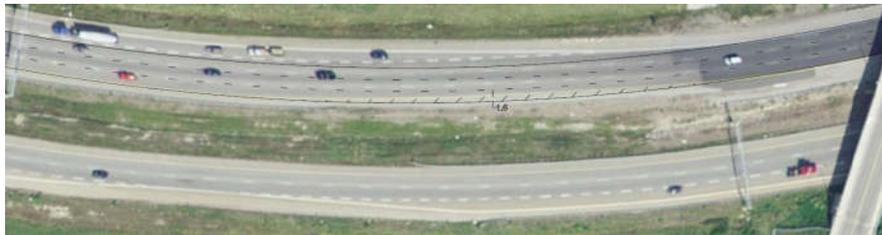
Figure 35 - Potential Pavement Marking Adjustment

In the southbound direction there is an alignment discontinuity that occurs wherein there is a tangent section of roadway between two curves, but within an intended smooth curve. We are unsure why the roadway was built this way as the design drawings do not show this occurring. It is difficult to attribute any collisions to this geometric aspect, however, it is clear that it catches drivers off-guard and leads to wandering in the lanes. The City could consider smoothing out the alignment through the use of pavement markings by shifting the flat area by approximately 1.6 metres, as shown in **Figure 35**. This would allow the outside yellow line to fall within the existing roadway platform.

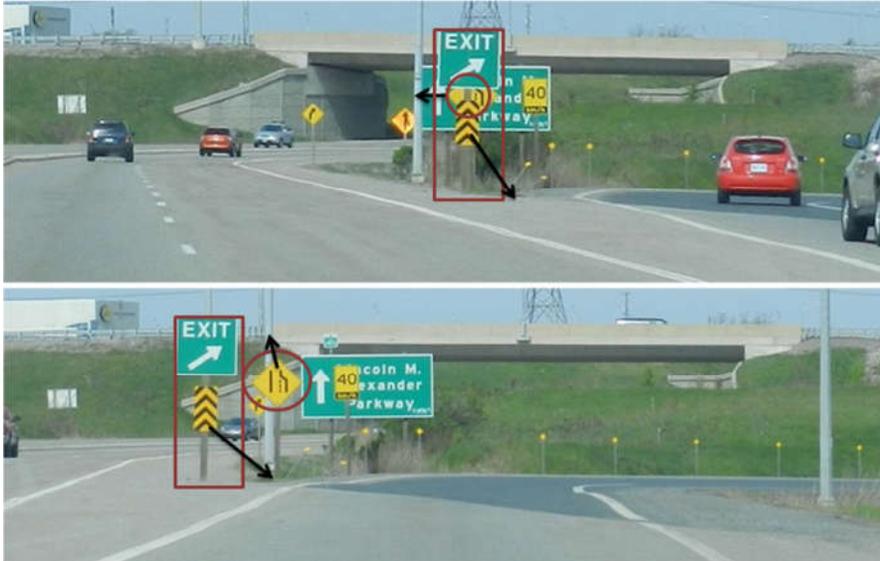
Figure 36 - Possible Signage Adjustments

There are several signs located within the gore area at the diverge between ramps 6 & 7a. Some of these signs are related to ramp 6 while other are related to ramp 7a. The City could consider making the following adjustments as illustrated in **Figure 36**:
