City of Hamilton
Red Hill Valley Parkway Safety Review (DRAFT)
B000325 | July 2013
B000325

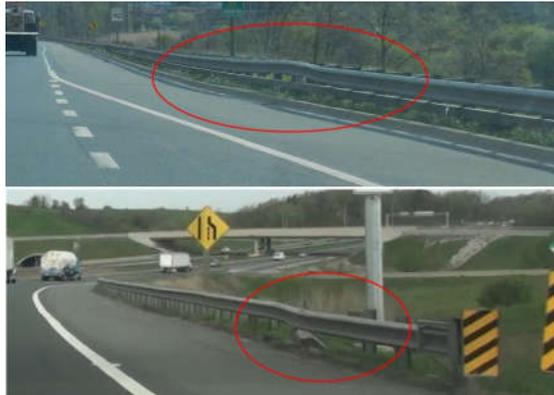
Figure 11- NB Main Line (View North from the Mainline); SB Mainline just west of Dartnall off-ramp (View West from the Mainline)

Roadside steel beam guide rail systems and concrete barriers contain evidence of impacting collisions at a number of locations. For the steel beam guide rail systems, depending on the severity, the damage could impede the structural integrity of the system. This could cause the system to function unexpectedly on a subsequent impact. **Figure 12** through **Figure 14** provides illustrative examples of some of the identified cases. Also, a number of plough markers mounted in advance of guide rail system end treatments were damaged and/or not vertically plumb.

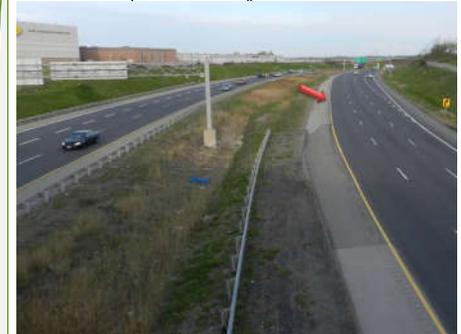
~~The mainline alignment discontinues through the horizontal curve just south of the Pritchard Road overpass. The horizontal curve contains a tangent section part way through the curve. The discontinuity is very noticeable when viewed from the Pritchard Road overpass. Figure 15 provides an illustrative example of this issue.~~

~~Figure 15 - View of Discontinuity in Horizontal Curve on the Mainline (View West from Pritchard Road Overpass)~~

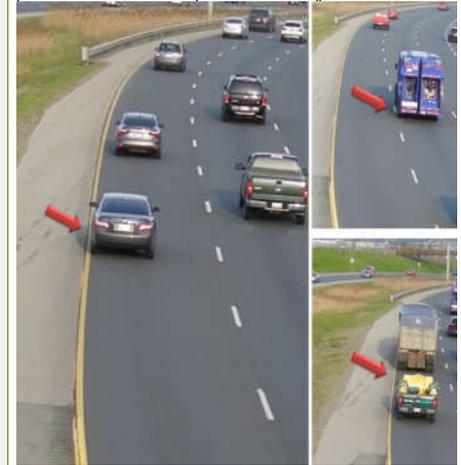
~~Many drivers were observed traversing or closely approaching the inside (median) edge line of the highway. Some vehicles were observed driving over the rumble strips and then overcorrecting to position themselves back into their travel lane. Overcorrection actions were observed less often during the peak hours, possibly due to lower speeds. Figure 16 provides illustrative examples of this case.~~

~~Figure 16 - Observed Cases of Swerve- and Overcorrection-Manoeuvres (View West from Pritchard Road Overpass)~~

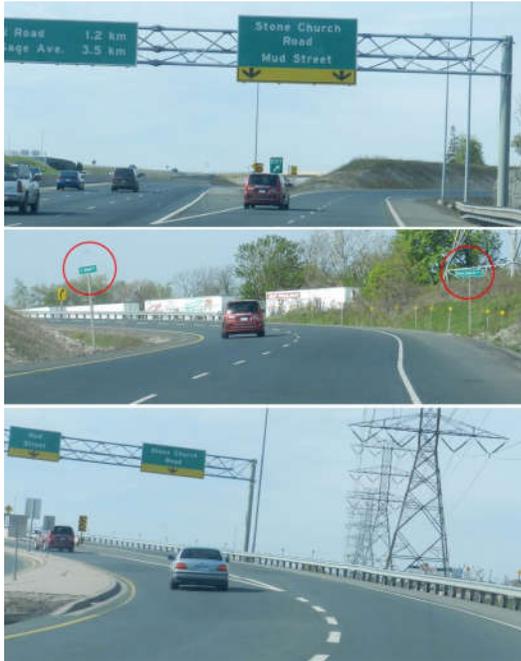
Figure 31 - Information Signs Leading to Mud Street and Stone Church Road (View South Successively) Traveling South

Small information signs indicating that the left lane leads to Mud Street and the right lane leads to Stone Church Road are located approximately 160 metres upstream of the forced diverge point for Mud Street and Stone Church Road, are directly behind curve warning signs and immediately before a curve. Since the information signs are small there is a good chance that a driver will not detect them. If the small information signs are missed the next available signage to inform road users of the appropriate lane decision are located at the diverge point. However, similar to the previous information signs, given the horizontal curvature of the ramp, the signs are not visible in advance of their placement and sudden lane changes, and potentially related conflicts, may occur in this area. To assist drivers, the City could consider installing a ground mounted advance diagrammatic sign (similar to example in **Figure 37**) on the right side of the road in the location of the existing small signs.

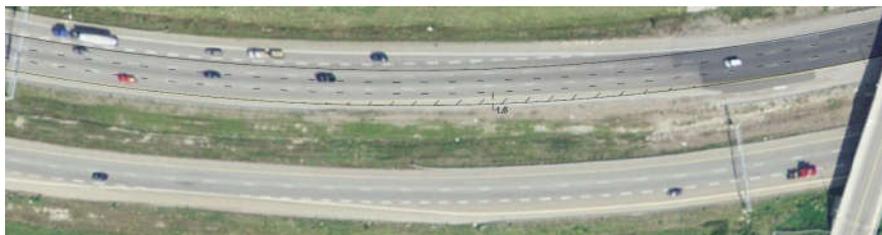
Figure 33.- Potential Pavement Marking Adjustment

In the southbound direction there is an alignment discontinuity that occurs wherein there is a tangent section of roadway between two curves, but within an intended smooth curve. We are unsure why the roadway was built this way as the design drawings do not show this occurring. It is difficult to attribute any collisions to this geometric aspect, however, it is clear that it catches drivers off-guard and leads to wandering in the lanes. The City could consider smoothing out the alignment through the use of pavement markings by shifting the flat area by approximately 1.6 metres, as shown in **Figure 35**. This would allow the outside yellow line to fall within the existing roadway platform, although it would be on the current paved shoulder and would require filling and regrinding of the existing edgeline rumblestrips. Final recommendations for this countermeasure would require additional examination of the road design that was not possible with the data provided for this study.
